**FARO PIT PLUG DAM**

**CONCEPTUAL DESIGN REPORT**

PROJECT NO.: 0257-019-01  
DATE: DECEMBER 19, 2003

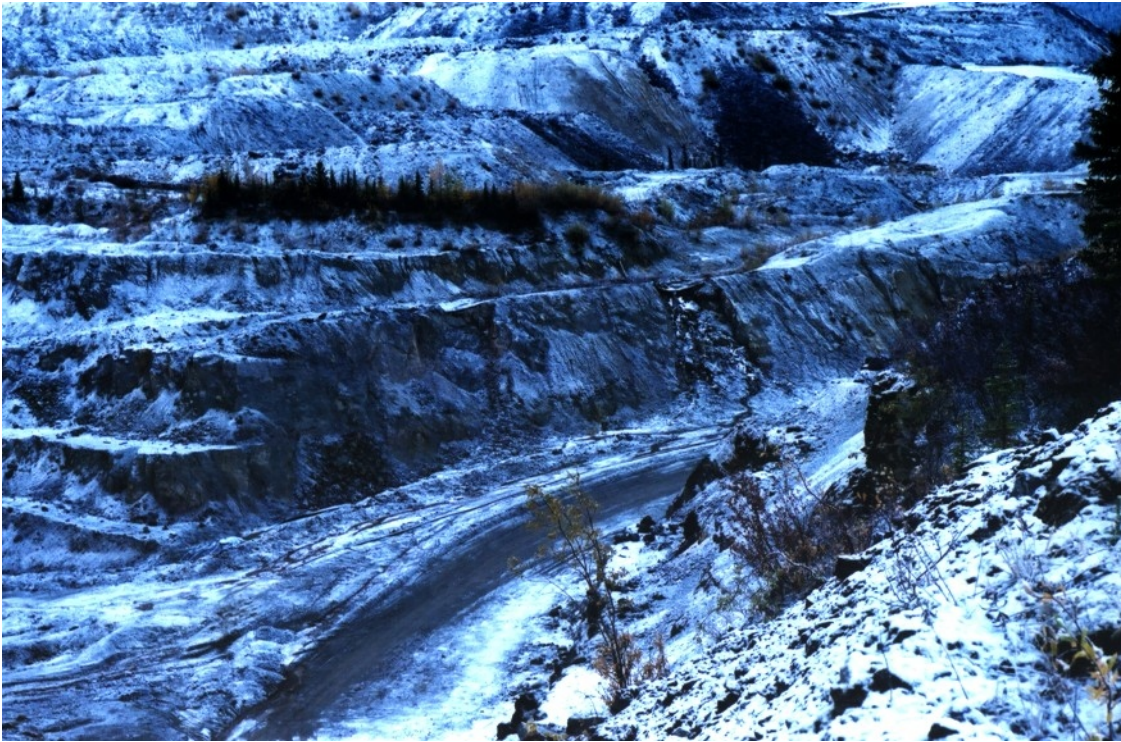
View of Plug Dam site from top of right abutment, looking downstream.

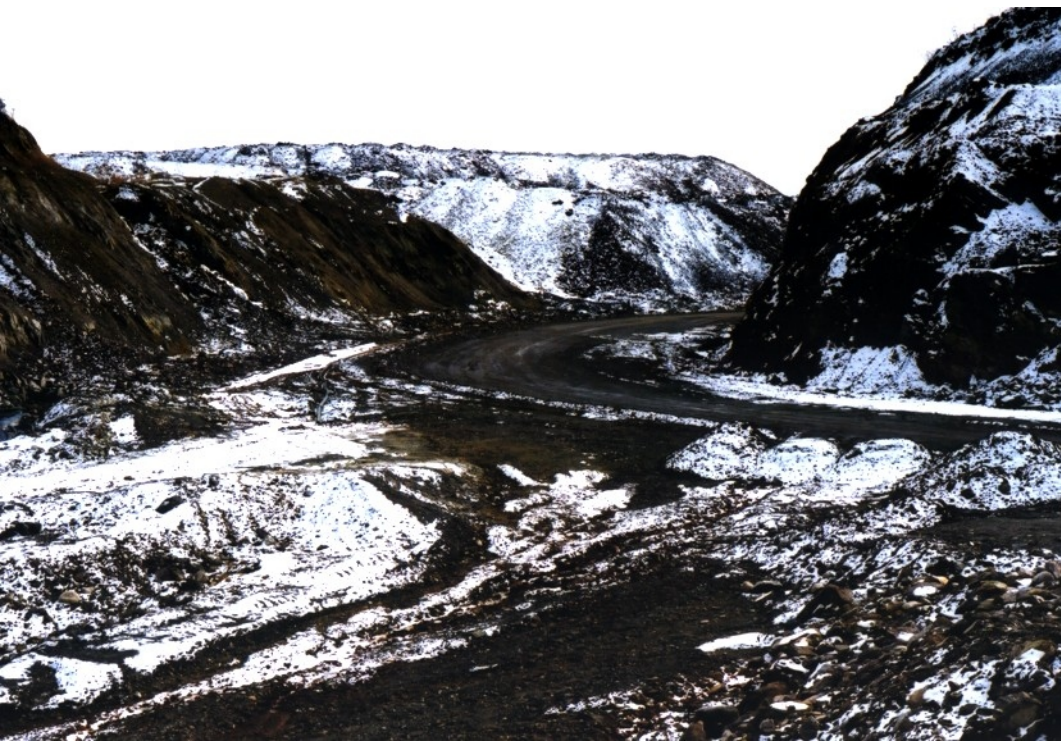
Plug Dam site looking downstream along haul road.

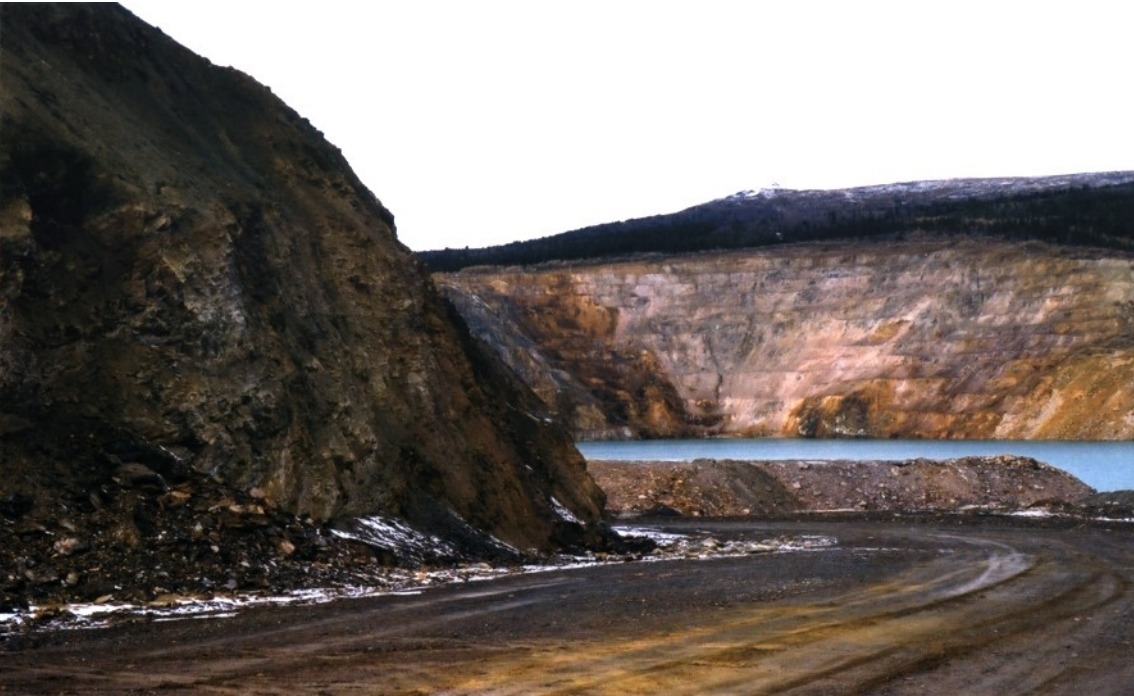
Looking upstream along toe of right abutment.

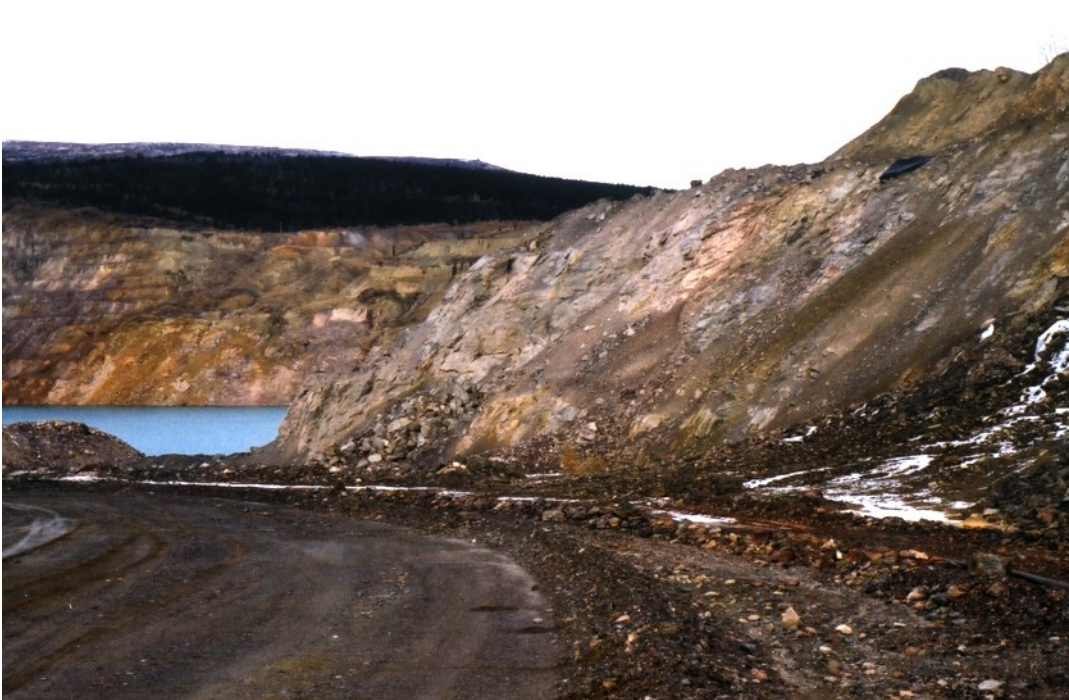
Looking upstream along toe of left abutment.

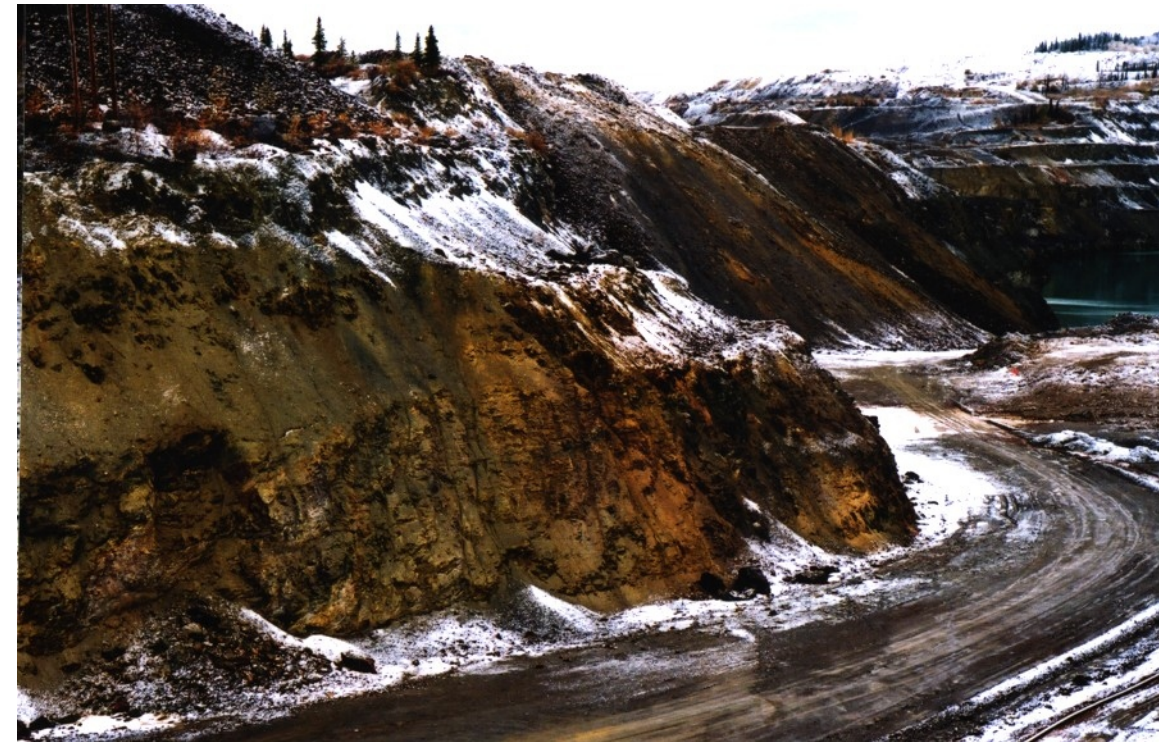
View of right abutment from top of left abutment.

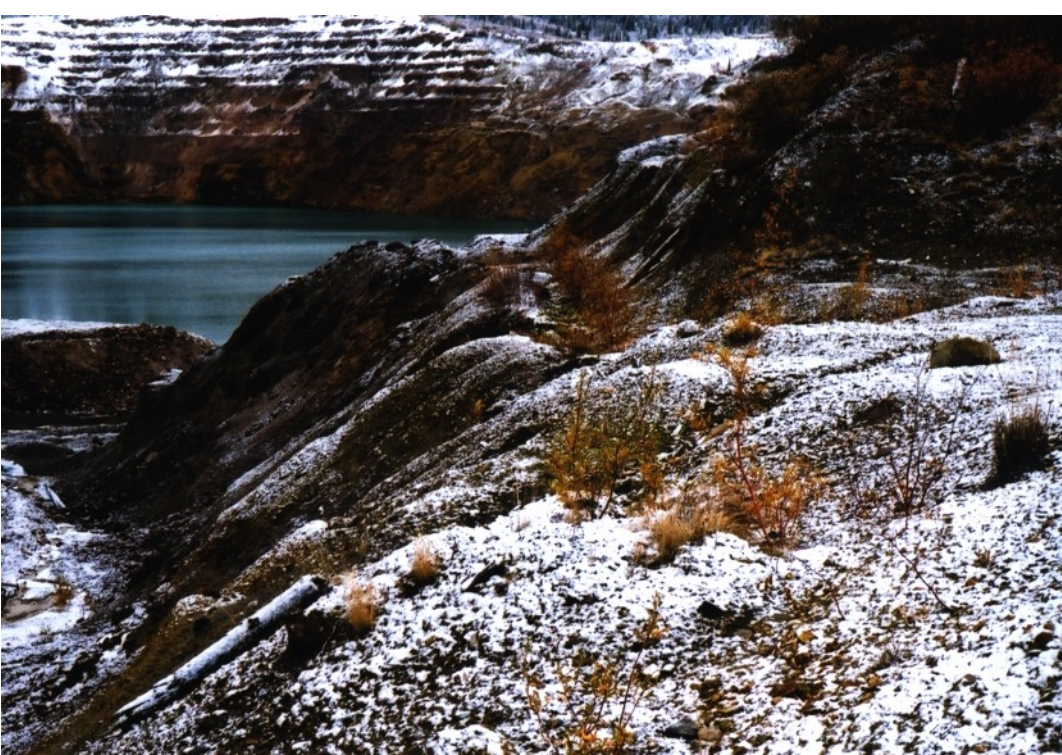
Looking upstream along top of left abutment. Diversion ditch and berm on bench.

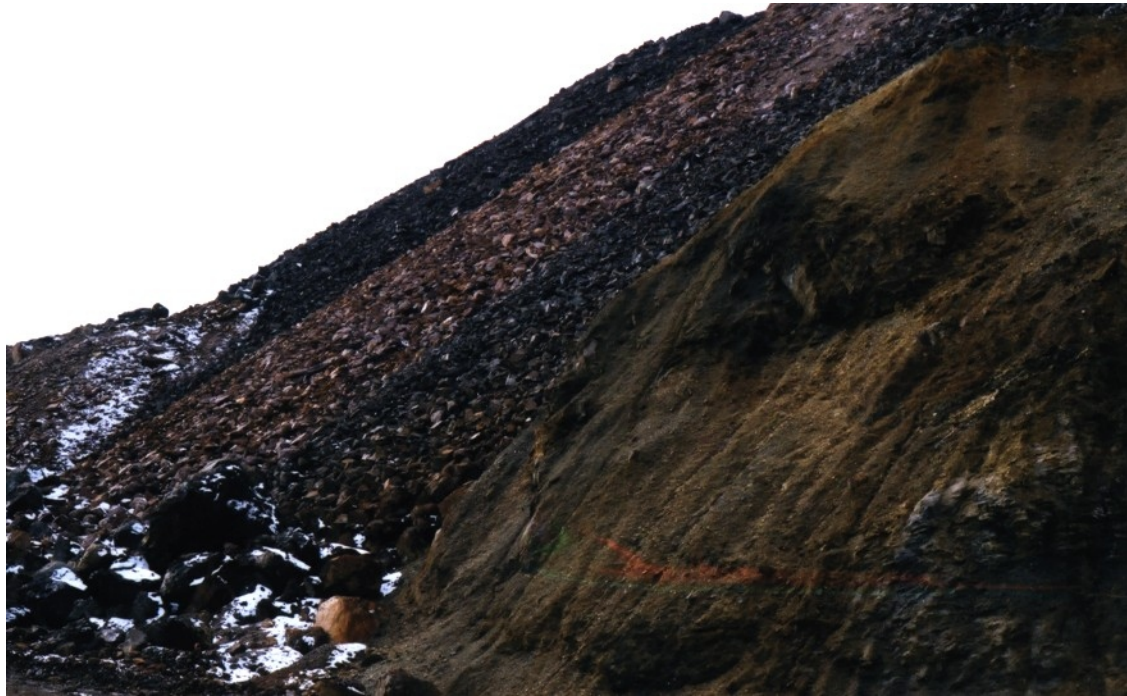
Edge of bedrock on right abutment at edge fo Zone II pit filled with waste rock.

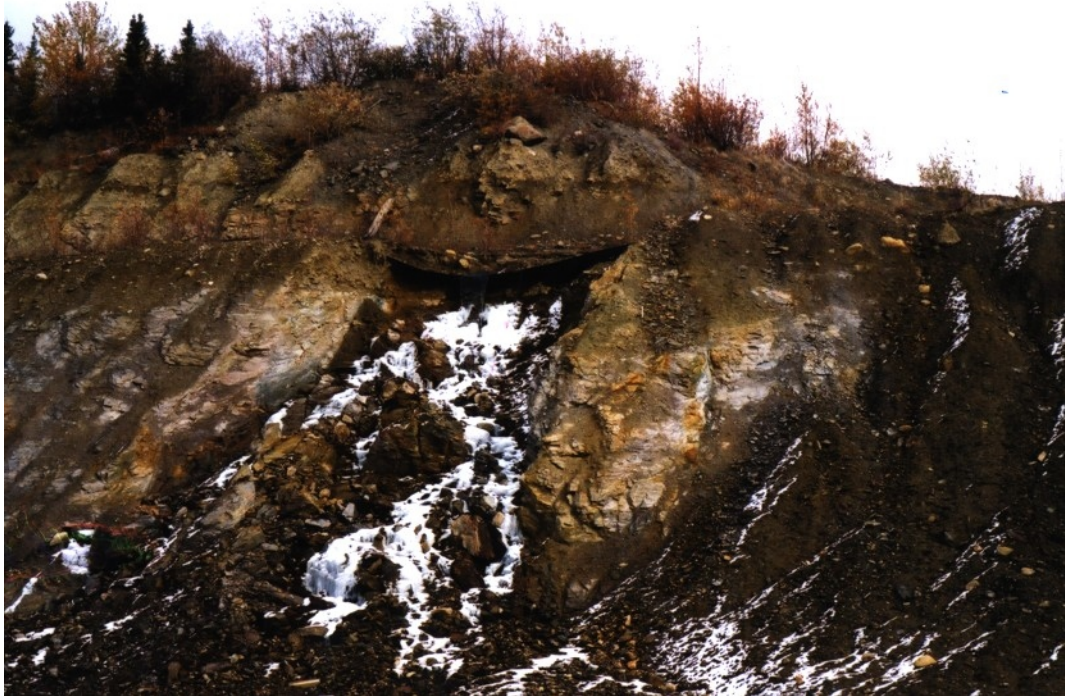
The measured joint sets are consistent with previous mapping carried out in the pit (PGML, 1975). At least 5 sets exist, including foliation joints, which lie in the plane of the foliation. Intersecting joints form unstable wedges in the left abutment. At least three wedge failures have resulted in slides affecting the lower bench between the haul road and elevation 1170 m amsl. These failures have destroyed part of the diversion ditch embankment on the 1172 bench resulting in portions of the HDPE liner becoming breached. Water from the diversion ditch flows down the left abutment face, downstream of the dam centreline.

Small - scale wedge failure in left abutment has breached diversion ditch and liner on upper bench

This item also includes lump sum allowances for relocating the pipeline from the Zone II pumping well, and re-directing the left abutment runoff diversion ditch. Currently the diversion ditch is breached in the vicinity of the dam site and water is flowing over the left abutment rock slope, across the dam foundation and into the Faro pit. Water in the diversion ditch comes from the waste dumps and slopes south of the dam. It may be possible to widen the bench at the crest of the dam and have the water flow directly into the Faro pit with the increased water level behind the plug dam. The pump well discharge could then be routed across the waste dump material and discharge into the diversion ditch. Mine site staff will be required to further assess these issues

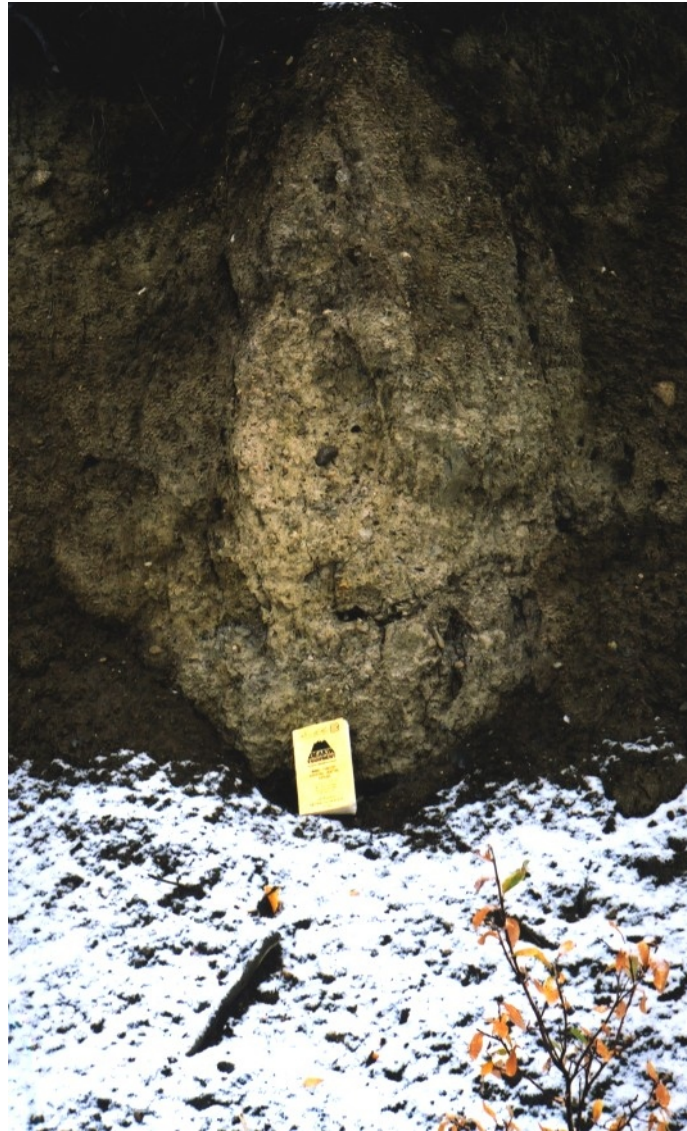
Exposure of Quaternary colluvial material in left abutment.

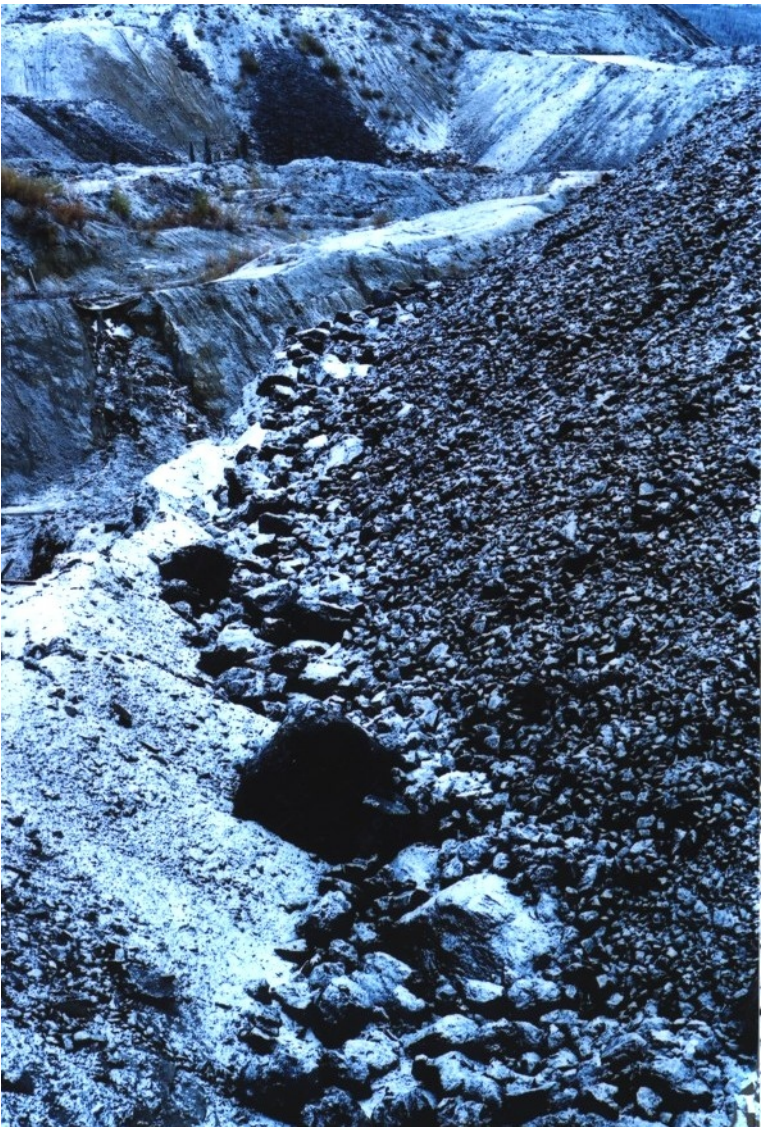
Toe of waste rock dump  
on top of bedrock in right  
abutment.

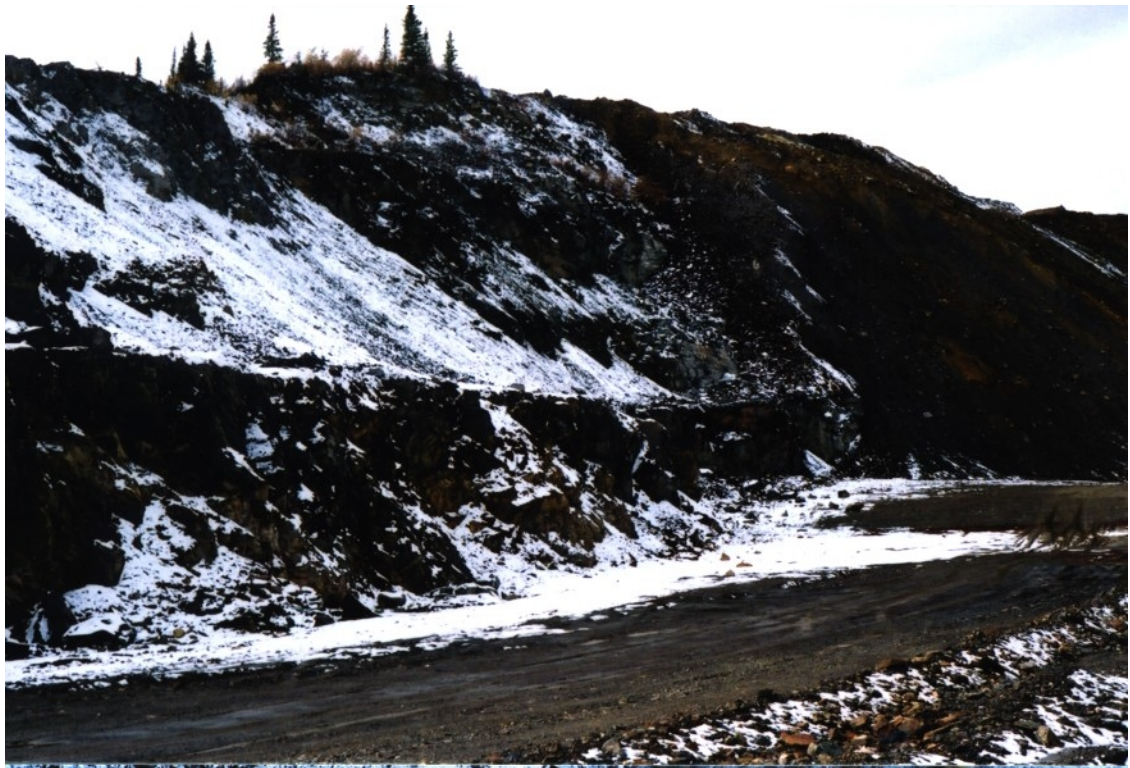
View of right bank bedrock pillar  
separating Faro Pit from Zone II Pit.
